THE SAN NIKLAW CAVE-SETTLEMENT

Keith Buhagiar

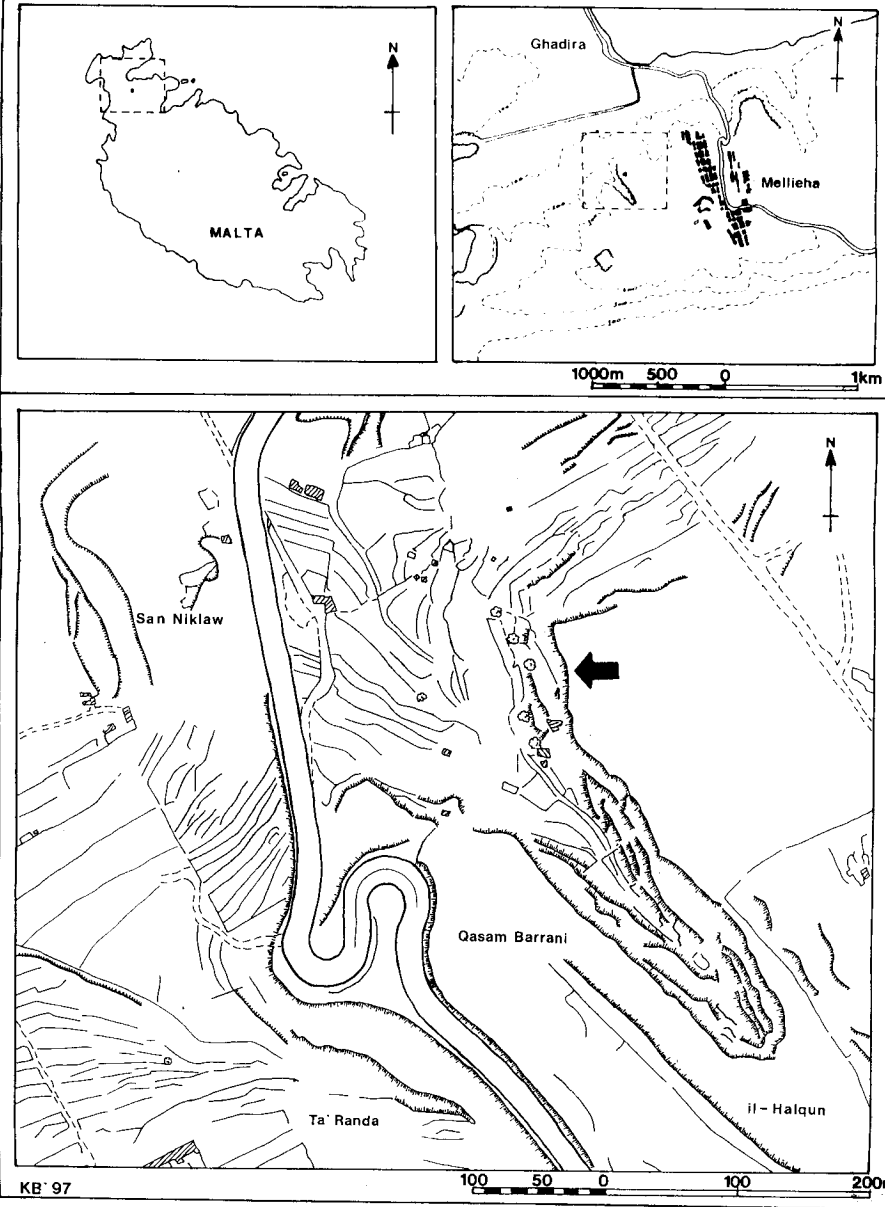
Fig. 1

Site Plan of the San Niklaw Area

Geography and History of the San Niklaw Site: The San Niklaw troglodytic settlement, situated at an altitude of c. 180 meters above sea level, is embedded in the sides of Mellieha Ridge and overlooks Ghadira Valley and Marfa Ridge (fig. 1). This cave settlement can be reached via a foot-path branching from the Mellieha by-pass which from Ghadira Valley, leads to Mellieha Ridge. Globigerina Limestone known as *il-gebla tal-franka*¹² in Maltese, predominates in this region. As is also the case with the San Pietru medieval settlement in Naxxar,¹³ the toponym of the fields surrounding this area is that of ta' San Niklaw.

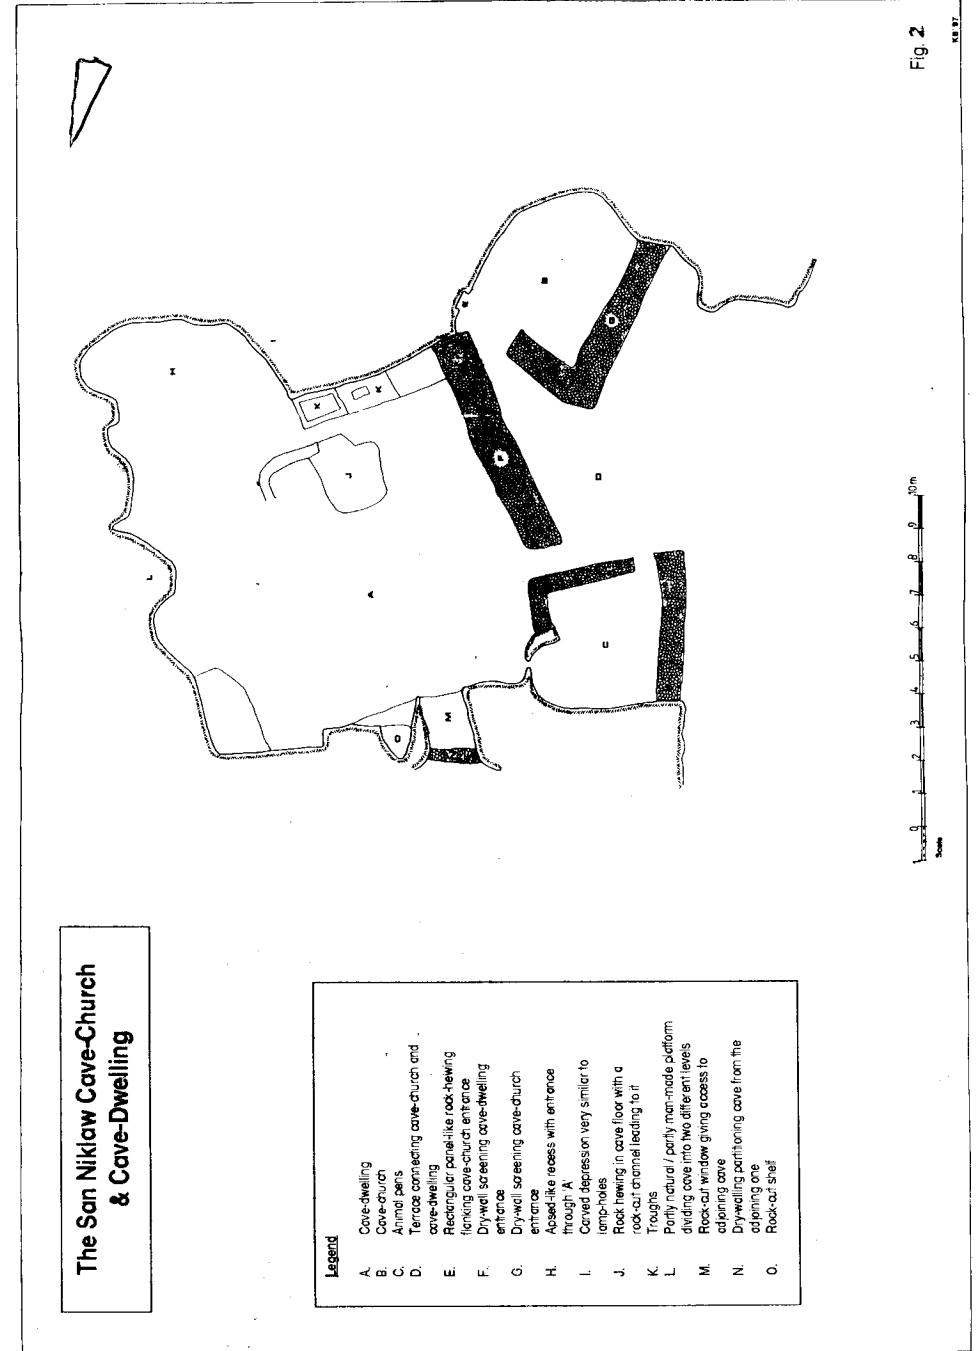
The San Niklaw Cave-Church: The largest cave (fig. 2; A), that used for man and animal habitation, is situated exactly towards the middle of the terrace (fig. 2; B). To the right is a half apsed rock wall enclosed by a rubble wall. This has been identified as the cave-church that Dusina mentions in his 1575 Pastoral visitations and is also considered as being associated with the *Beneficio di S. Nicolao delta Mellecha* mentioned in a 1436 document.¹⁷

The San Niklaw Cave-Dwelling: Separating this cave-dwelling from the adjoining cave-church is a dry-wall (fig. 2; F), a few courses of which are still present. In antiquity, this must have reached up to the roof of the cave entrance as is the case with the inner part of the dry-wall, marking the boundaries of the San Niklaw cave-church

This cave, which is of a quite considerable size has an almost rectangular form, the only exception being an apsed-like recess (fig. 2; H), towards the right hand side interior, of the church. Interesting features present in this area are roundish, rock-carved depressions, in the right hand side wall of the cave (fig. 2; I), which are very similar to lamp-holes. Seven incisions are present in all. The upper four are placed at the same height and are almost equidistant. The lower three, also having the same height, are positioned almost directly beneath the upper slots. The utility of these features is difficult to determine with certainty, but these could have functioned as rafter supports.

Rock hewing in the cave flooring, can be observed towards the middle of the cave (fig. 16; J), and consists of an almost squarish depression in the ground connected at one end to a long, narrow, rock-cut canal. A proper archaeological investigation is necessary and this would surely help in assessing the function of this rock-cut feature. Towards the right hand side of this rock-cut feature are two troughs (fig. 2; K), which are cut in a rock bench.

Marked 'M' is a rock-cut window which gives access to an adjoining cave, also used for habitational purposes. Dry-walling 'N', partitions these two caves. Marked 'O' is a rock-cut shelf, 'C', is a chamber enclosed by dry-walling. This chamber can only be accessed from the terrace and possibly gave shelter to the cattle owned by the troglodytes inhabiting these caves.

On its inner side facing the entrance, a partly natural, partly man-made platform, 1.80m high is present dividing this cave into two different levels (fig. 2; L). This upper level of the cave, although having a shallow rock roof spans into the cliff-face for c. six meters. This rock platform provides ample proof to suggest that before the troglodytes settled in this cave, the upper level was the original height of the flooring. Rock cutting, in the upper part of the cave at a later stage, divided the cave into two different levels.

Description of Remains: The San Niklaw settlement is a particularly impressive example of a troglodytic settlement (fig. 2). The relative inaccessibility of the large
